### 3 The trouble check of TPS signal

#### 1. Troubles

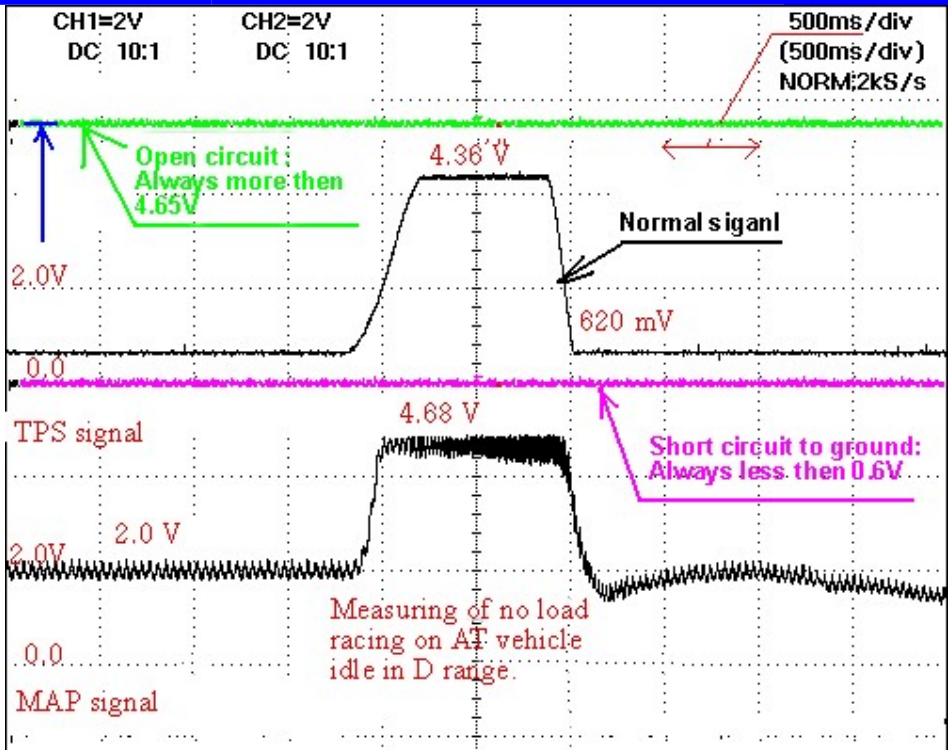
1. Malfunction of TPS sensor	
Cause of trouble	Malfunction TPS or wiring circuit failure(Signal, Ground and Reference)
Counter action	Healing by cause of trouble TPS replace Wiring circuit repair
Engine state	The surging is taken place when acceleration and RPM cycling is happened when recovering to idle.
Signal view

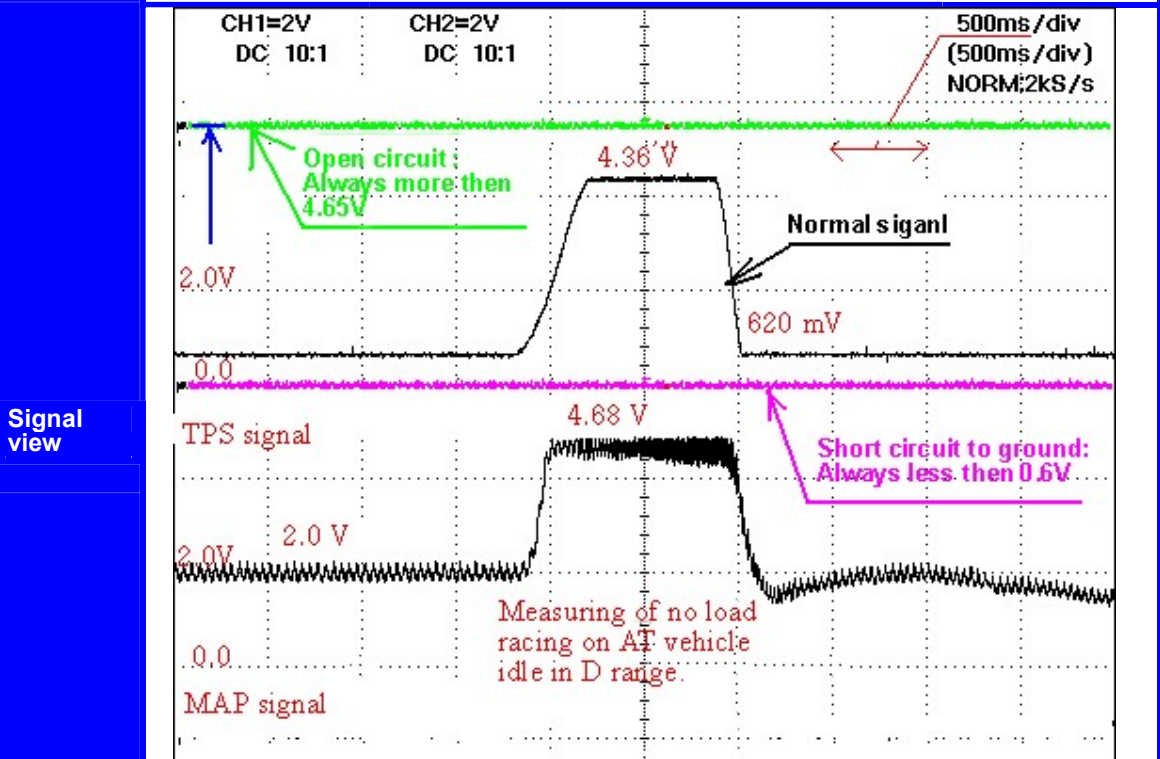
<b>Cause of trouble</b>	Trouble detection more than one of the followings Abnormal TPS (Abnormal sensing) Bad connecting of TPS signal line or short to ground TPS reference line (5V) short to ground
<b>Counter action</b>	Healing by cause of trouble TPS replace TPS wiring circuit repair

**Engine state** The surging is taken place when acceleration and RPM cycling is happened when recovering to idle.

In idle state(Case of throttle valve closing), TPS signal is from 0.6 to 2.0[volt] range. And in case that TPS signal line is broken, TPS voltage is close to 5[volt] because TPS signal line is connected with 5[volt] power supply line of "Full up" resistance.

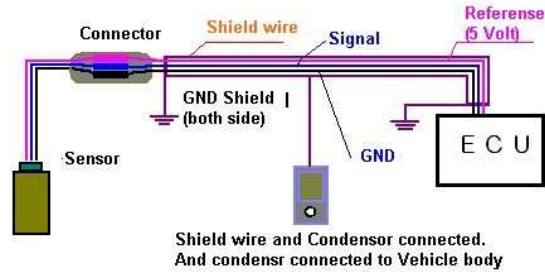
**Cause of trouble**  
 Trouble detection more than one of the followings  
 :Occur trouble during very short time(Below 100usec) and TPS adaptation value is very small at the moment  
 Abnormal TPS (Abnormal sensing)  
 TPS bad connecting

**Counter action**  
 Reset adaptation value after cleaning connector. Nevertheless, if the problem is still happened, make shielded wire as below picture.

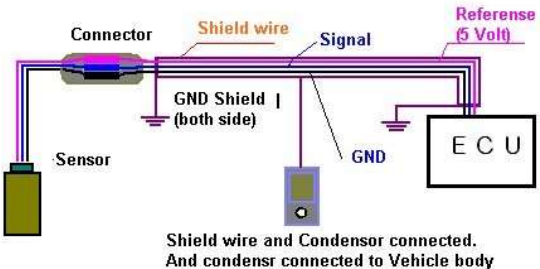
5. Wrong idle(without acceleration)	
<b>Cause of trouble</b>	<p>Idle is not detected in ECU                      Abnormal return of acceleration cable                      Micro Cut-off is occurred                      Resistance variation of TPS wiring</p>
<b>Counter action</b>	<p>Healing by cause of trouble                      Replace acceleration cable if it is not normal,                      Connect directly TPS wiring(Signal, ground, reference line) from TPS connector to ECU terminal without middle connecting part (Remove resistance in wiring).                      TPS signal line should be shielded as below picture</p>

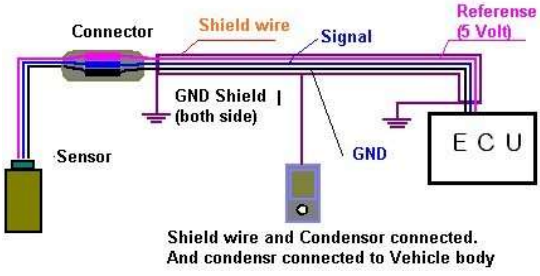
6. TPS noise detection with idle state	
Counter action	<p>ECU recognizes continuously acceleration/deceleration for a moment. 6.1 It is influenced by external electric from TPS wiring</p> <p>Shield wiring of ignition system and keep away from TPS wiring. Connect directly after shielding TPS wiring(Signal, ground, reference line) from TPS connector to ECU terminal without middle connecting part. TPS signal line should be shielded as below picture.</p>

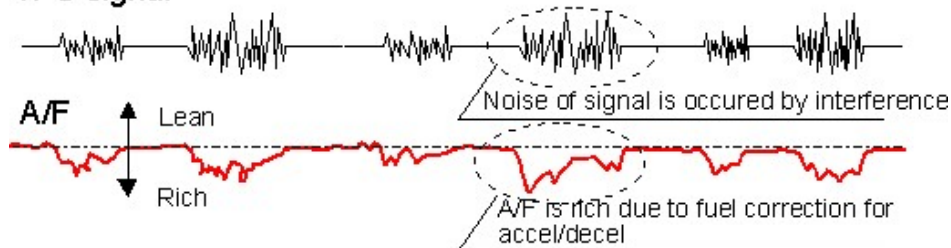
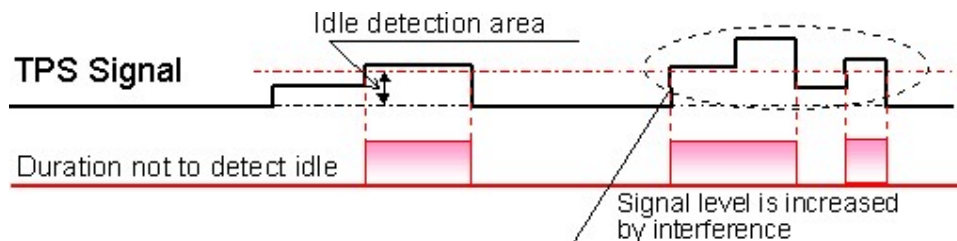
**Problem description** : RPM cycling is sometimes taken place in idle state with engine vibration. And a lot of CO emission(1.7%) comes from exhaust gas in idle state.

**Cause** : RPM cycling is taken place because ECU doesn't recognize idle state by noise detection of TPS signal. Whenever noise is detected, ECU recognizes it as working rapidly acceleration pedal. And it is cause of rich injection control as adding fuel correction when acceleration

< Rich injection control by fuel correction when acceleration >

< Amplification of noise signal : ECU doesn't recognize idle state >

**Explanation** : The noise is not occurred after separating TPS signal line from TCU connecting. But if it is TPS signal line which must be used with TCU connecting, noise may be reduced as separating TCU from connecting part as far as possible.

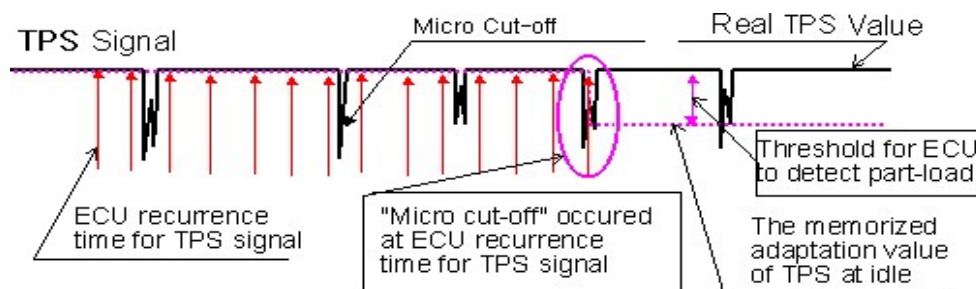
**Problem description :** Sometimes engine is rough idle state. The floating is occurred without idle recovery and surging is taken place when acceleration. TPS value that is measured from scanner is normal but TPS value is very small in idle state.

**Cause :** TPS signal is cut for very short time (  $\approx 40 - 120 \mu\text{sec}$  ). ECU regard it as TPS value (Below 0.05volt) that is measured with micro cut-off phenomenon in idle state (If the idle TPS value which is memorized in ECU is less than normal one, it is set to idle TPS value). After that if it is again returned normal, ECU recognize it as working acceleration pedal and also don't apply idle correction.

**Explanation :** Finally, ECU doesn't detect idle in spite of real idle state. So, it led to rough idle. The current vehicle (Production after Jun.1996 model year) have no problem with micro cut-off (Duration is less than 0.8) because ECU change TPS value after elapsed 0.8 [sec] in case that current TPS value is less than memorized one.

**Enlargement of application :** If engine is rough idle, first compare "absolutely TPS value" with "TPS adaptation value" from scanner in idle state. If these two values have difference more than 1.2 [°TPS], ECU doesn't detect idle in spite of real idle state. So, you must find root cause after inspecting why this phenomenon is happened.

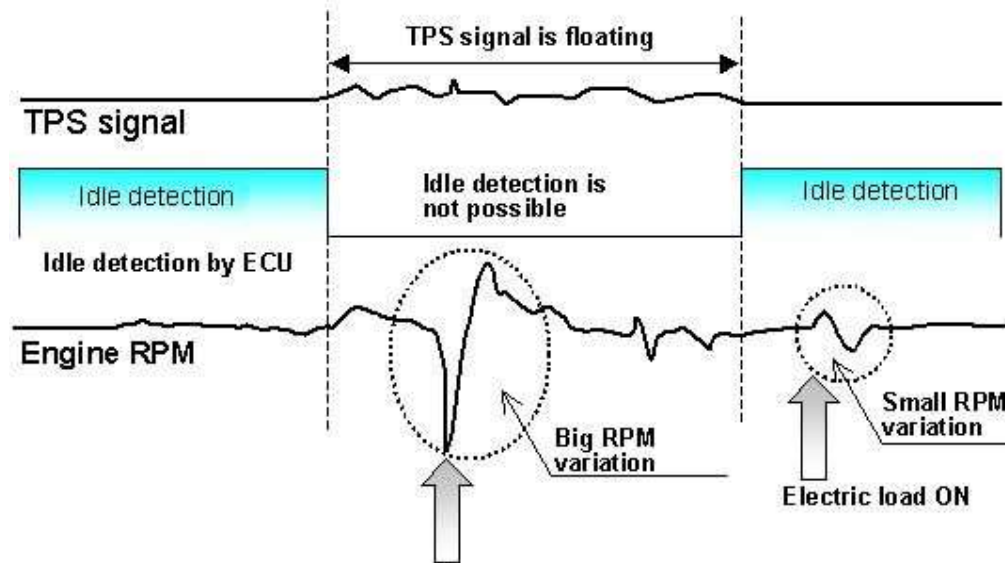
**Problem description :** Sometimes engine is rough idle state. The floating is occurred without idle recovery and severe RPM cycling is taken place with electric load or A/C ON.

**Cause :** If engine becomes so hot, TPS signal is unstable in idle state by bad connection around fuse box. So, ECU doesn't recognize idle state because the unstable signal is higher than "TPS adaptation value in idle". It results in rough idle.

**Enlargement of application :** If engine is rough idle, first compare "absolutely TPS value" with "TPS adaptation value" from scanner in idle state. If these two values have difference more than 1.2 [°TPS], ECU doesn't detect idle in spite of real idle state. So, you must find root cause after inspecting why this phenomenon is happened.

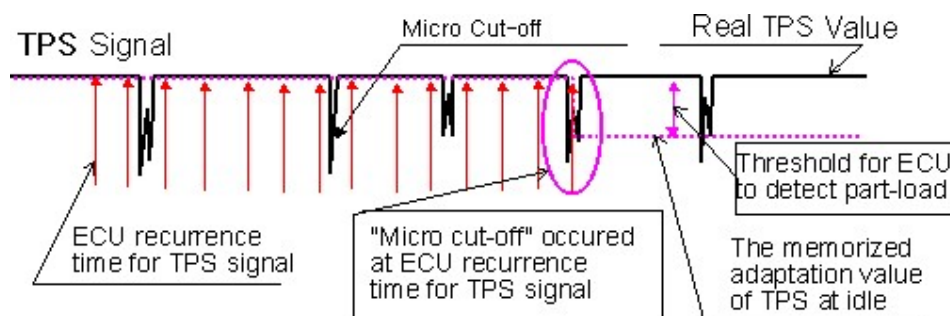
< Figure 3 : TPS signal micro cut off >

□ If and TPS signal is suddenly goes down to 0V and adapt it as idle state and then back to 1.0V again after 1.0V has been adapted as idle state, what will be happened?

In this case, 1.0V of TPS pedal pushing is detected and will make above problem.

=> Actually, TPS signal micro cut off can be happened but the root cause is still not found out and counteractions are just to improve connection conditions of TPS connector and to change logic. For example, if TPS value is decreased very fast, ignore current value but use previous value. As it is difficult to improve above problem in the filed, ECU must be change with new improved logic.

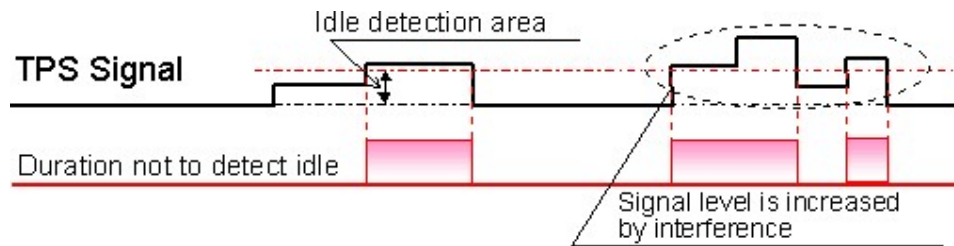
< Figure 4: TPS signal is floating by external influence >

□ In case of that idle state is not detected due to higher signal voltage by bad TPS ground condition TPS, engine speed must be within normal range (below 1200rpm) to adapt current TPS value as idle data. But what if idle speed is higher than 1200rpm or what if engine is stalled? In that case, as TPS have no chance to learn idle state, above mentioned problem will be happened intermittently (especially with overheated engine, or with hot weather ).

=> In fact, if idle detection is failed during idle state, engine speed can be higher than idle speed. Because, spark advance is set to MBT(Maximum spark advance for Best Torque ) out of idle area. Even though air quantity to the cylinder is same, engine speed increase with higher spark angle. (Remark: 10-15rpm per 1deg of spark angle.). Therefore if TPS value is bigger than adapted value and engine speed is higher than idle then ECU detect as pushing throttle pedal. In some cases, engine can be stalled. In this case, besides of engine speed increase by spark advance, engine stall can be happened due to no compensation for the electric load. The counteraction for this is that if other component uses same ground line with TPS, then separate TPS ground line and ground it separately. And check TPS connector condition.( best action is to connect all TPS line : Signal, ground and reference line from TPS to ECU directly).

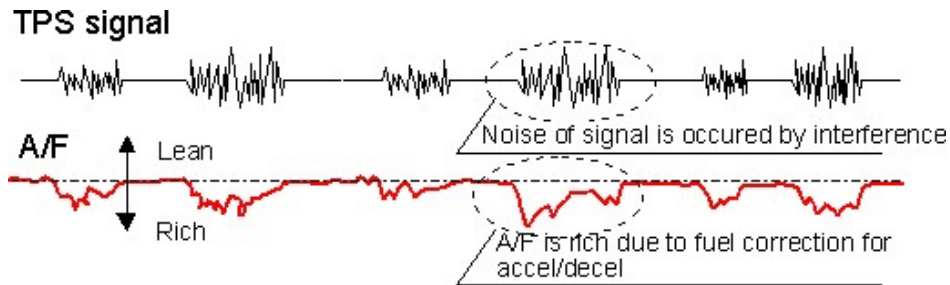
< Figure 5: TPS noise >

□ In case of noise on TPS signal, how ECU can avoid wrong detection of this noise signal as real throttle pedal movement? What if accel and decel compensation is happened by this noise?

=> This problem also can be happened well. Especially, if TPS signal is used for other functions(TCU ), this problem can be happened.

In that case, it do not give any influence to the driver but high emission or engine noise at idle can be occurred.

The counteraction for this problem is to connect all TPS line : Signal, ground and reference line from TPS to ECU directly.

But if TPS line is shared with TCU (Transmission Control Unit) then find good ground connection location between ECU and TCU where shows less noise. ( This action is for car body electronic engineer but if there are many accessories installed by owner(audio...), it is same )
