### 3 The trouble check of TPS signal

#### 1. Troubles

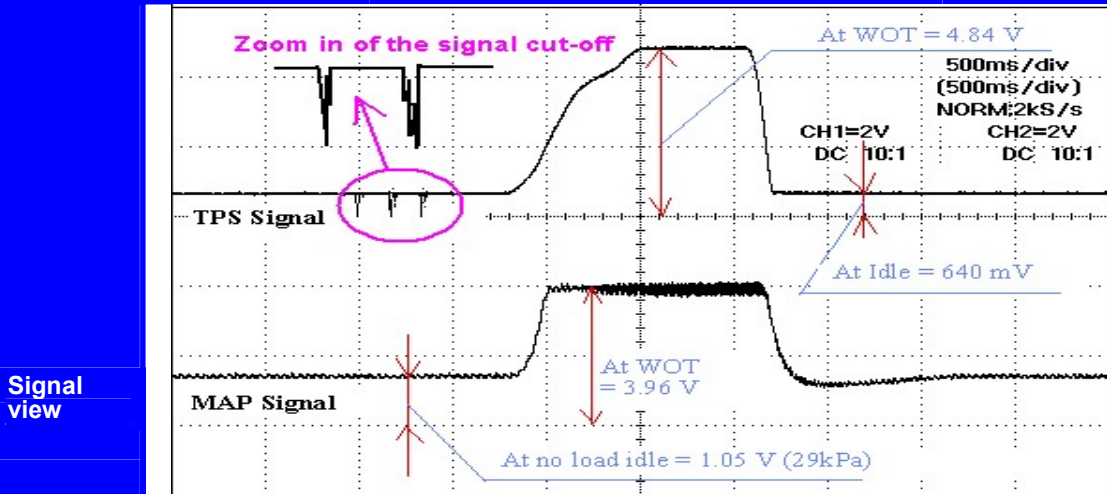
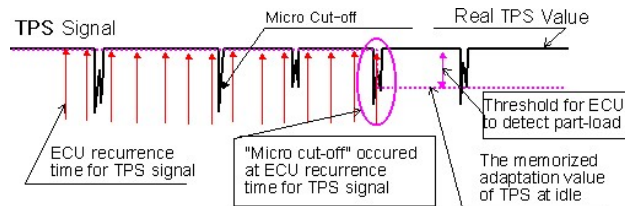
**4. Abnormal TPS signal by Micro cut-off**

**Cause of trouble**  
 Trouble detection more than one of the followings  
 :Occur trouble during very short time(Below 100usec) and TPS adaptation value is very small at the moment  
 Abnormal TPS (Abnormal sensing)  
 TPS bad connecting

< Reference > Engine stall or vibration with idle engine state is expected. But don't need to repair it if engine operation is normal.

**Engine state**  
 The severe engine vibration is occurred in idle state and sometimes engine stall is taken place. In case of floating occurrence, idle RPM is not returned to target.

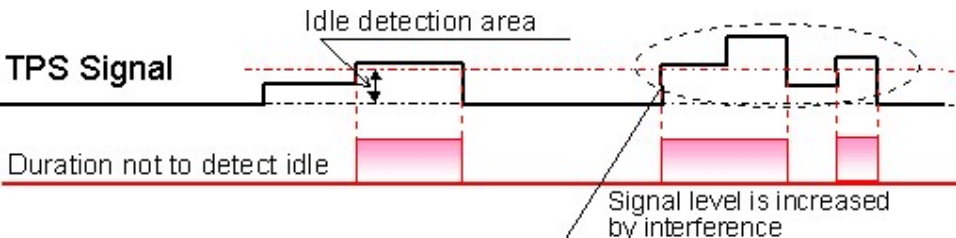
<b>Signal view</b>	<p>&lt; Insert Signal &gt;                      Save it as picture file after measuring signal with out of idle state by bad return of acceleration cable. And record TPS and TPS adaptation value when idle at the bottom of picture.</p>

5. Wrong idle(without acceleration)	
<b>Cause of trouble</b>	<p>Idle is not detected in ECU                      Abnormal return of acceleration cable                      Micro Cut-off is occurred                      Resistance variation of TPS wiring</p>
<b>Counter action</b>	<p>Healing by cause of trouble                      Replace acceleration cable if it is not normal,                      Connect directly TPS wiring(Signal, ground, reference line) from TPS connector to ECU terminal without middle connecting part (Remove resistance in wiring).                      TPS signal line should be shielded as below picture</p>

<b>Engine state</b>	<p>1.The severe engine vibration is occurred in idle state and sometimes engine stall is taken place. In case of floating occurrence, idle RPM is not returned to target.                      2.When take off or acceleration, severe surging is happened.</p>

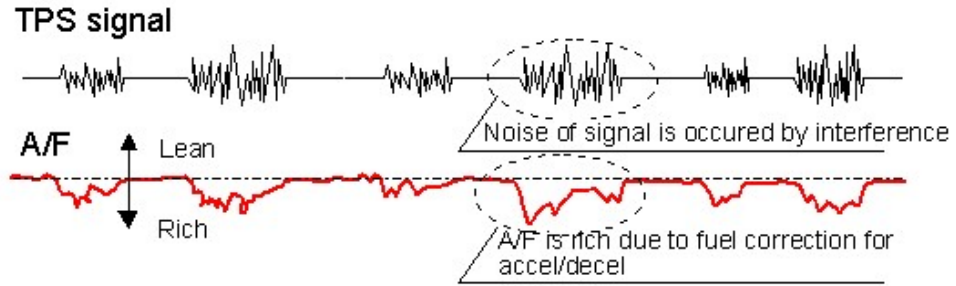
Signal view

6. TPS noise detection with idle state	
Counter action	<p>ECU recognizes continuously acceleration/deceleration for a moment. 6.1 It is influenced by external electric from TPS wiring</p> <p>Shield wiring of ignition system and keep away from TPS wiring. Connect directly after shielding TPS wiring(Signal, ground, reference line) from TPS connector to ECU terminal without middle connecting part. TPS signal line should be shielded as below picture.</p>

<p style="text-align: center;">&lt; TPS signal line / TPS ground line / TPS reference line &gt;</p> <p>In case of connecting with TCU, separate it TCU In case of connecting with vehicle sensor and other sensors, Do like 6.2</p>
Engine state	<ol style="list-style-type: none"> <li>1. The severe engine vibration is occurred in idle state and sometimes engine stall is taken place. In case of floating occurrence, engine is not returned to target idle RPM.</li> <li>2. When take off or acceleration, severe surging is happened.</li> <li>3. The emission may be increased too much in idle state.</li> </ol>

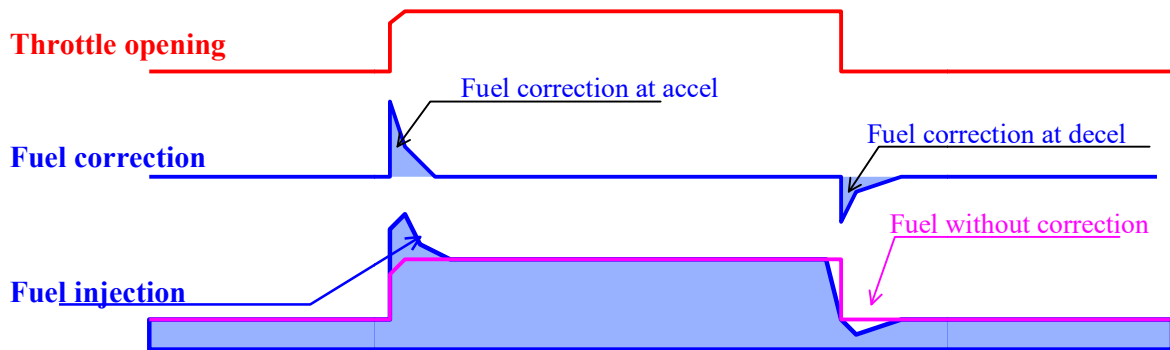
< Trouble : Impossible to detect accel or decel. >

- Big shock or hesitation during accel or decel.
- Insufficient acceleration response.

Move TPS and check if real signal value is moving. The problem of constant signal due to line break or short circuit can be detected by ECU self diagnosis and if you connect Hi-scan, you can find the root cause.
